# GRINLING GIBBONS

## at Trinity College Chapel, Oxford

### Martin Hall

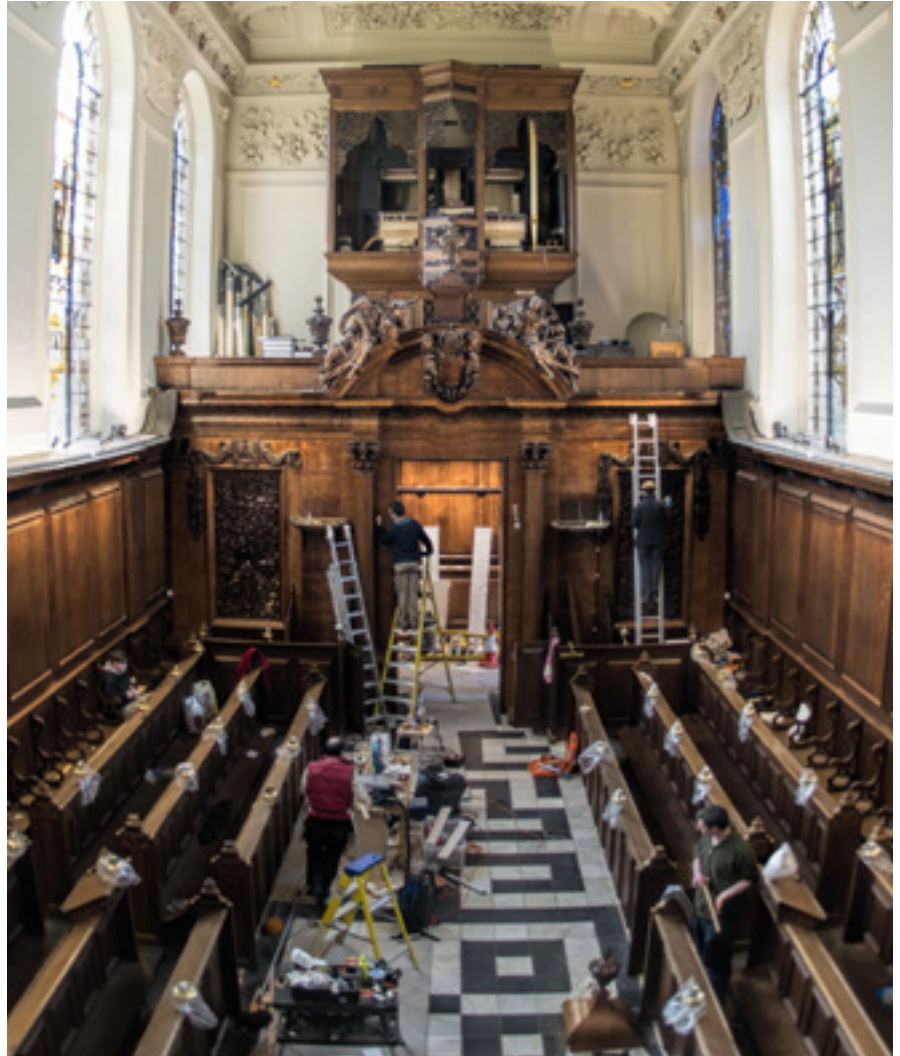
*Conservators at work on Grinling Gibbons' screen which divides the antechapel from the nave (All photos: Bruce Hammersley)*

On entering the chapel today, the most striking feature is Grinling Gibbons' magnificent screen which divides the antechapel from the nave. It features fluted Corinthian columns and an arched pediment, topped with carvings of the Evangelists, and has two fretwork panels either side, with putti (infant angels) at their centres.

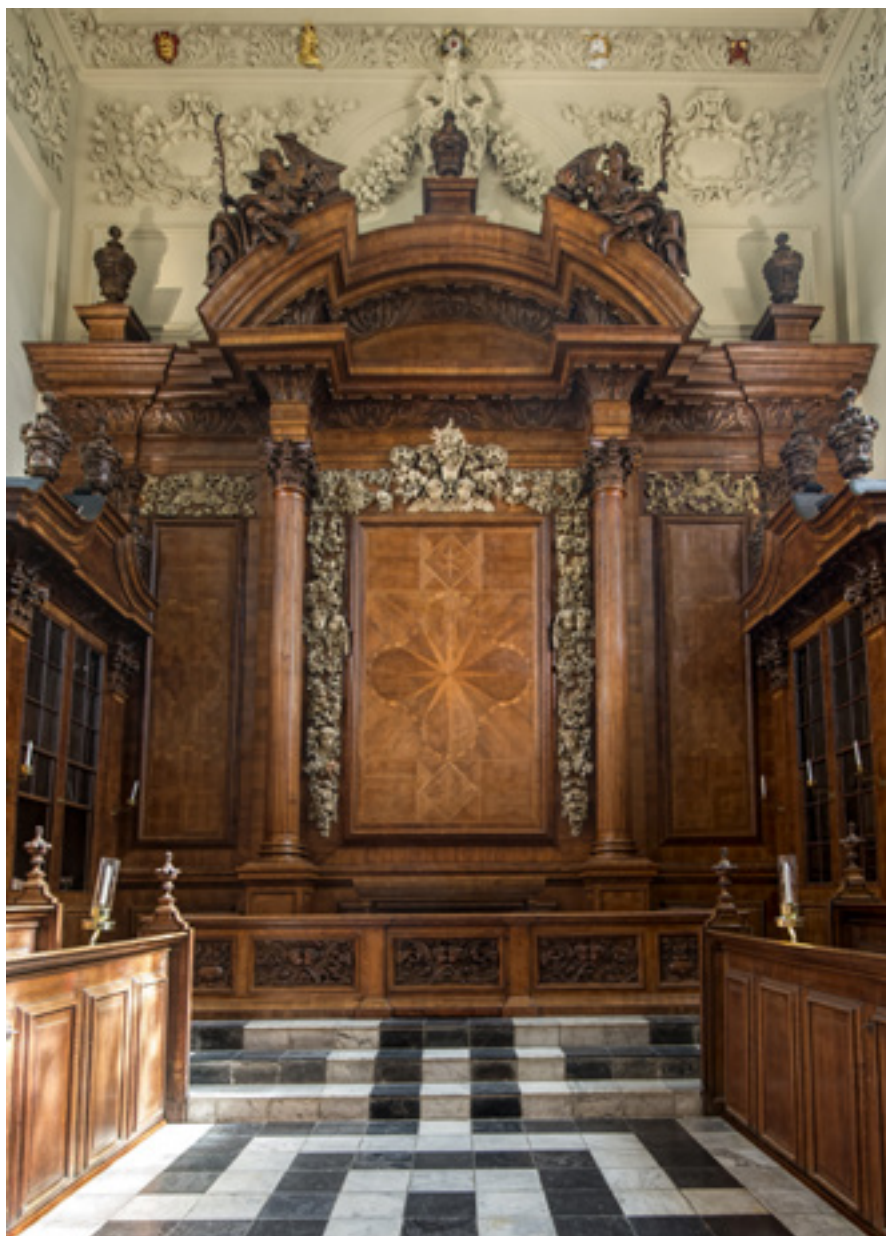
The conserved reredos against the dried out east wall of the chapel

An environmental monitoring survey was carried out by Brian Ridout of Ridout Associates to evaluate the level of damp and relative humidity. The evidence showed that moisture levels in the east wall were excessive, especially at its base. Fortunately for the important woodwork, conditions elsewhere in the chapel were found to be relatively benign.

It was decided to repair and conserve the existing stonework. A lime mortar was used to fill in any voids and a lime mortar shelter-coat was applied over the surface.

At the same time, the ground level was lowered at the foot of the wall and a drainage trench (or 'French drain') filled with free-draining gravel was created to enable it to dry out.

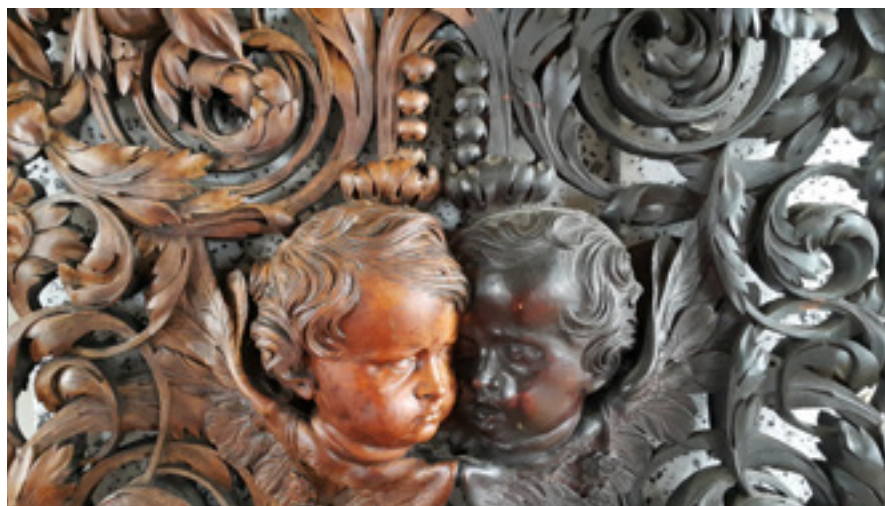
*The partially cleaned faces of putti from the antechapel screen: the thick varnish had been applied in the 1860s, obscuring fine detail in the Bermudan cedar carvings*

The pierced cedar panels and the figures on the pediment had been finished in a thick, dark varnish, obscuring the quality of the original carving. A key piece of research indicated that this dark scheme was a Victorian intervention. In 1867, following a visit to Trinity, Mr WG Rogers presented a paper to the Royal Institute of British Architects in which he noted:

Many of the chapel’s important wood carvings had retained this dark finish for 150 years, so ‘winding the clock back’ to before the Victorian intervention was a drastic proposal. However, the combination of the varnish analysis and historical research convinced the college and the diocesan advisory committee to allow the carvings to be returned to the appearance that Grinling Gibbons and Bathurst intended. As much of the dark varnish as could safely be removed was carefully lifted to reveal the carvings beneath in their original glory.

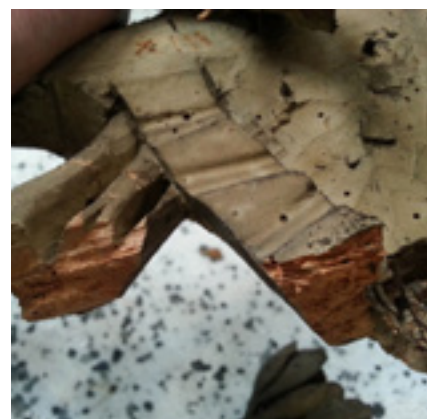
*Woodworm damage in carvings of the reredos*

Many areas had been so badly eaten away by common furniture beetle that they were composed more of voids than substance. These elements were consolidated using poly vinyl butyral in

ethanol (2–3% in solution), which had been used successfully on other Gibbons limewood carvings.

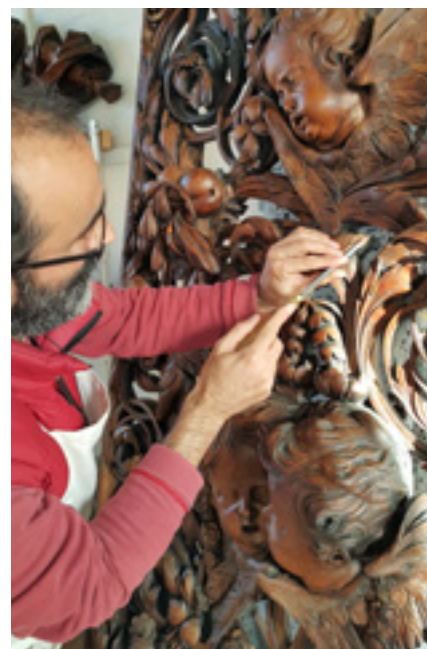
*Conservator David Mendieta carving a repair to replace a missing leaf tip*

Using mid-19th and early 20th-century photographs, Alan Lamb was able to determine which elements had been lost over time and a number of these were replaced. The decision on what to replace was generally guided by the ‘six-foot rule’: if it can’t easily be seen from six feet away, don’t replace it.

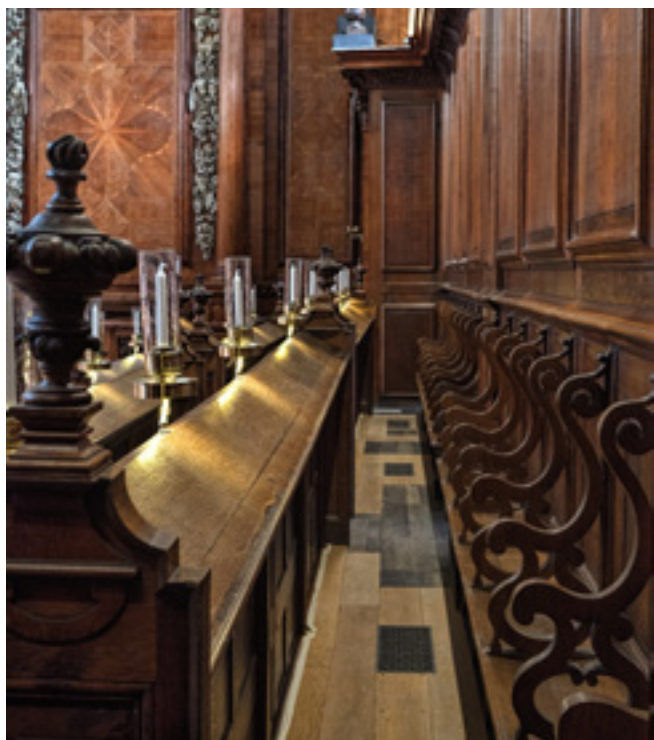
*Repairs to the raised floor below the pews, with a mixture of new European oak boards and sections of salvaged originals*

The supports to the raised floors beneath the pews had deteriorated over time and many were supported on pieces of brick and timber. The main oak bearers had disintegrated, mainly from dampness and death watch beetle. The floor structure was removed entirely then carefully reconstructed, reusing original material where possible.

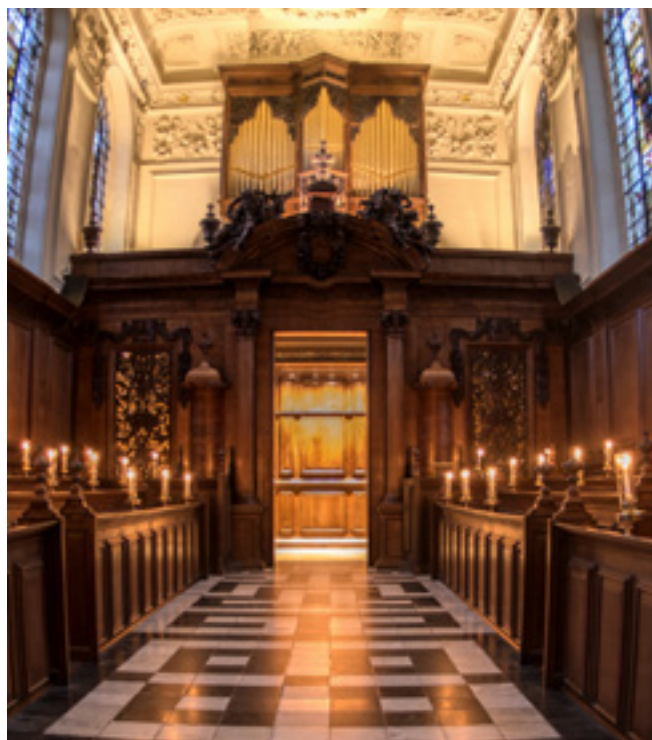
*The new lighting scheme: LED light pads beneath the candle holders provide additional lighting during services.*

A new lighting scheme was essential because the main light sources were 500w halogen lamps which sat crudely above the timber cornices and constituted a fire hazard. Designed by church-lighting specialist Mark Sutton Vane Associates,

the new scheme includes modern LED lighting, much of which highlights particular features and has transformed the internal appearance of the chapel.

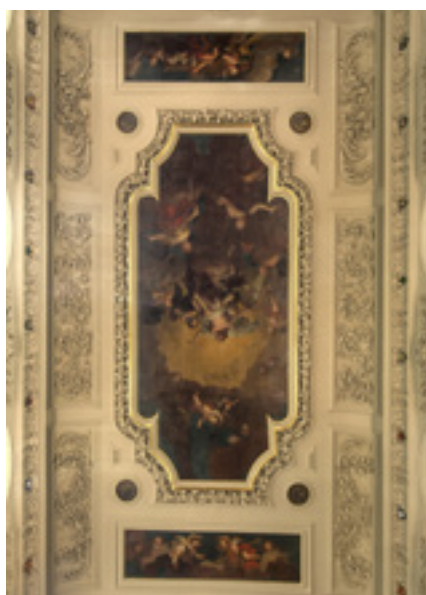
*Detail of the ceiling paintings and plasterwork after cleaning and revarnishing*

The ceilings were carefully cleaned and missing elements of plasterwork were restored by Cliveden Conservation. Because repairs to the ceiling paintings had been so crudely executed in the past, it was not realistically possible to revert back to the original paintwork. It was therefore decided to clean the old varnish off and re-varnish. A matt finish was chosen because movement in the past had resulted in an uneven surface, and the reflections from the old glossier varnish had been distracting. This has enabled a better view of the paintings.
